## AIR WEAPONS CONTROL SYSTEM 412L

QUARTERLY RELIABILITY PROGRAM

REPORT NO. 9

31 March 1963

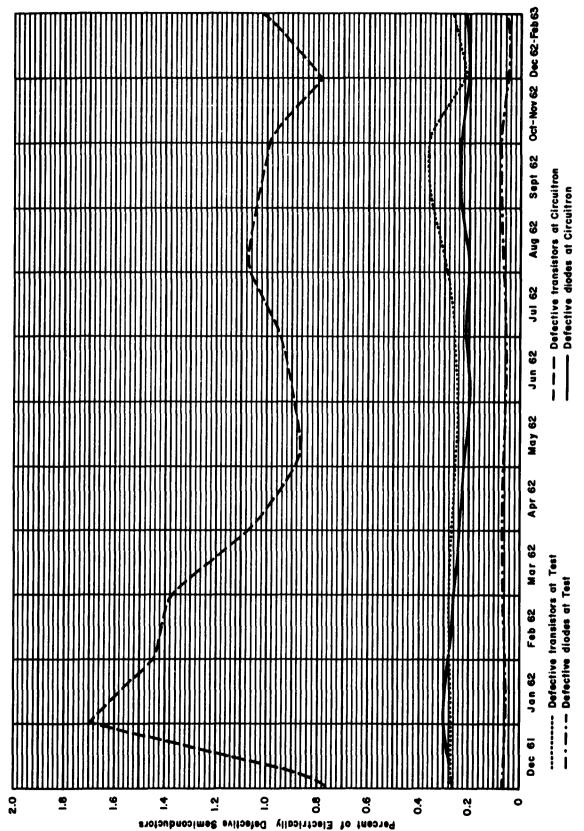
Figure 2. Monthly Semiconductor Electrical Defect Chart

- 4) Figure 2 is a graphic representation of semiconductor electrical defects reported from the Circuitron and unit test levels.
